**Flood Control Project Maintenance
Levee Inspections**

Fall 2014 Levee Maintenance Deficiency Summary Report

San Joaquin River Basin

Reclamation District No. 2075 McMullin

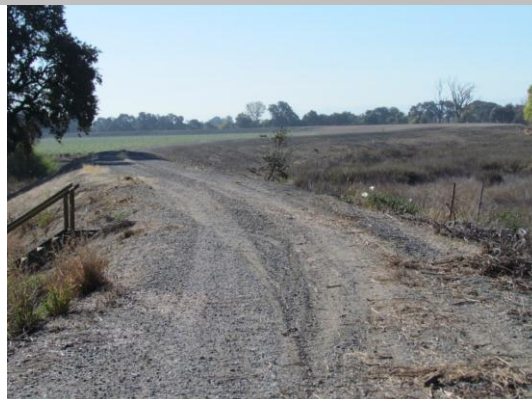
Photo 1 of 1 : FA_2014_RD2075_315_2_20141104_00001.jpg

LM Start	0.11	Rating **	A	Issue No.	2
LM End	2.32	Issue Type +	Ma	Location *	WS
Category	Earthen Levee			GPS Latitude/Longitude	
				Start	End
Item	Vegetation			37.748402 °	37.731575 °
				-121.289762 °	-121.293763 °
DWR ID	DWR_RD2075_01_f_2014_2				
Action/Comments					
Control annual grass and weeds on the levee slopes and easements. Inspector Comments: District has done a great job removing unwanted grasses from the levee slopes.

Looking downstream from levee mile 0.11 both landside and waterside levee slopes has been maintained.

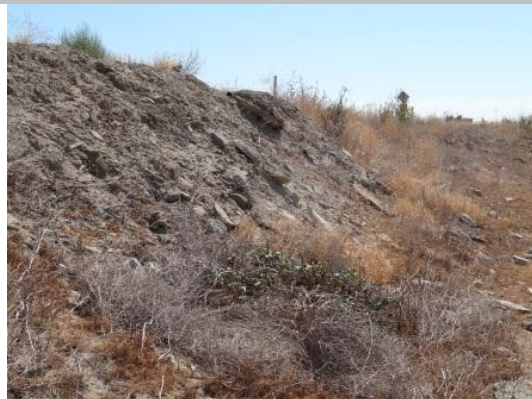
Photo 1 of 1 : SJR2014_RD2075U01RM64.34_1.jpg

LM Start	5.34	Rating **	M	Issue No.	12
LM End	5.35	Issue Type +	Ma	Location *	WS
Category	Supplemental			GPS Latitude/Longitude	
				Start	End
Item	DWR Erosion Survey			37.727933 °	37.727933 °
				-121.274491 °	-121.274491 °
DWR ID

Inspector Comments: 09/10/2013: No significant change observed.
09/13/2012: No significant change observed.
08/18/2011: No significant change observed. Some new material added to the water side levee slope, but the added material is loose and seems not helping the levee protection.
10/05/2010: No significant change observed. Levee slope has minimal vegetation and lacks rip rap protection. Sandy material found on the lower and middle slope is an undesirable material to have on a levee.
08/05/2010: Recommended for annual assessment and monitoring during flood events, per CLRO.
08/20/2009: No major change since last visit; site is located in an oxbow; slope surface consists of very sandy material; there is a tree on site leaning and with exposed tree roots; site is recommended as a local maintenance issue, per CLRO CES Evaluation 2008 Report; Eddy Cordoza from the district is aware of the site and is looking for recommendation; site is previously rated "U".

08/17/2007: Site is close to an irrigation pump inlet. [2014 Site ID:RD2075U01RM64.34]

Looking downstream of the erosion site.
